# Manhole Inspection Summary

Manhole # S43OO\_030MH

Insp Date: **12/11/07 9:49 AM**

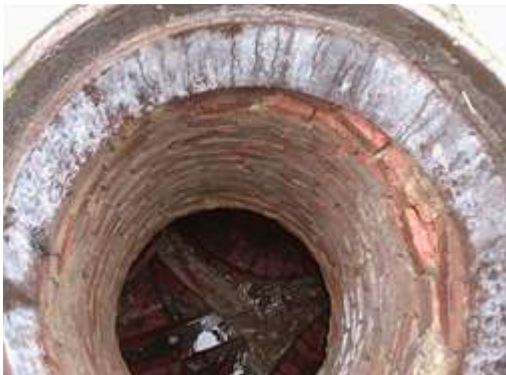
Defect 3

**Frame** Offset: **0.5** (in.) Condition: ☐ Sound ☐ Cracked ☒ **Leaks**

Frame Leaks

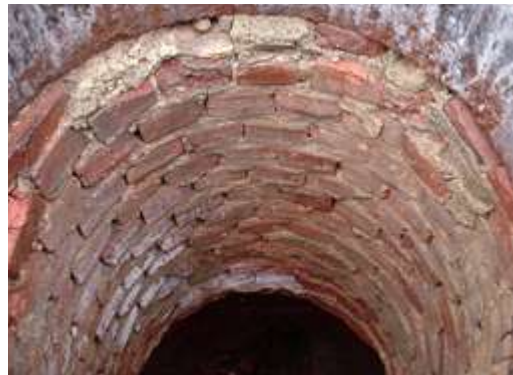
Defect 2

Infiltration: ☐ None ☐ Joint ☐ Cracks ☐ Mortar ☐ Roots ☒ **Wall**

Infiltration

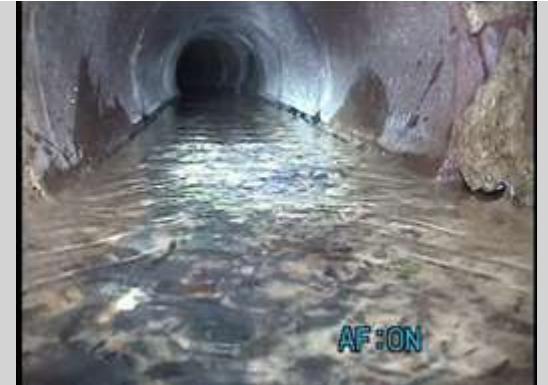
12 O'Clock Outflow

10 in. Circular Gravity Sewer  
Pipe Out @ 12 O'Clock

Pipe Height: **9.6** (in.) Rod and Bar (Angled)  
Pipe Material: **Clay** ☐ Pipe Lined  
Invert Depth: **11.50** (ft.) Flow Characteristics: **Slow**  
Deposits: ☒ None ☐ Mud ☐ Sludge ☐ Debris ☐ Grease  
Silt Depth: (in.) Deposits Extent:  
Infiltration: **None** Pipe Seal Cond: **Sound**

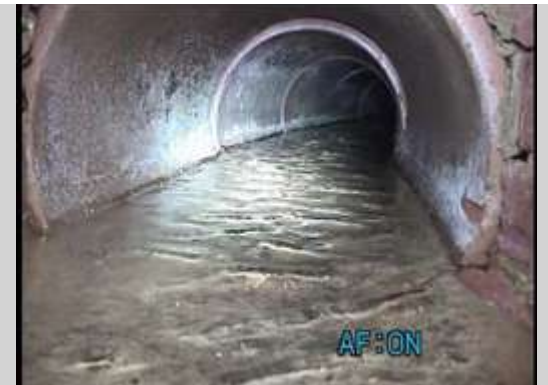
7 O'Clock Inflow

10 in. Circular Gravity Sewer  
Pipe In @ 6 O'Clock

Pipe Height: **9.6** (in.) Rod and Bar (Angled)  
Pipe Material: **Clay** ☐ Pipe Lined  
Invert Depth: **11.40** (ft.) Flow Characteristics: **Slow**  
Deposits: ☒ None ☐ Mud ☐ Sludge ☐ Debris ☐ Grease  
Silt Depth: (in.) Deposits Extent:  
Infiltration: **None** Pipe Seal Cond: **Sound**
